### Service Instructions MR013/04/I

Title: Optional 80K shield temp alarm adapter

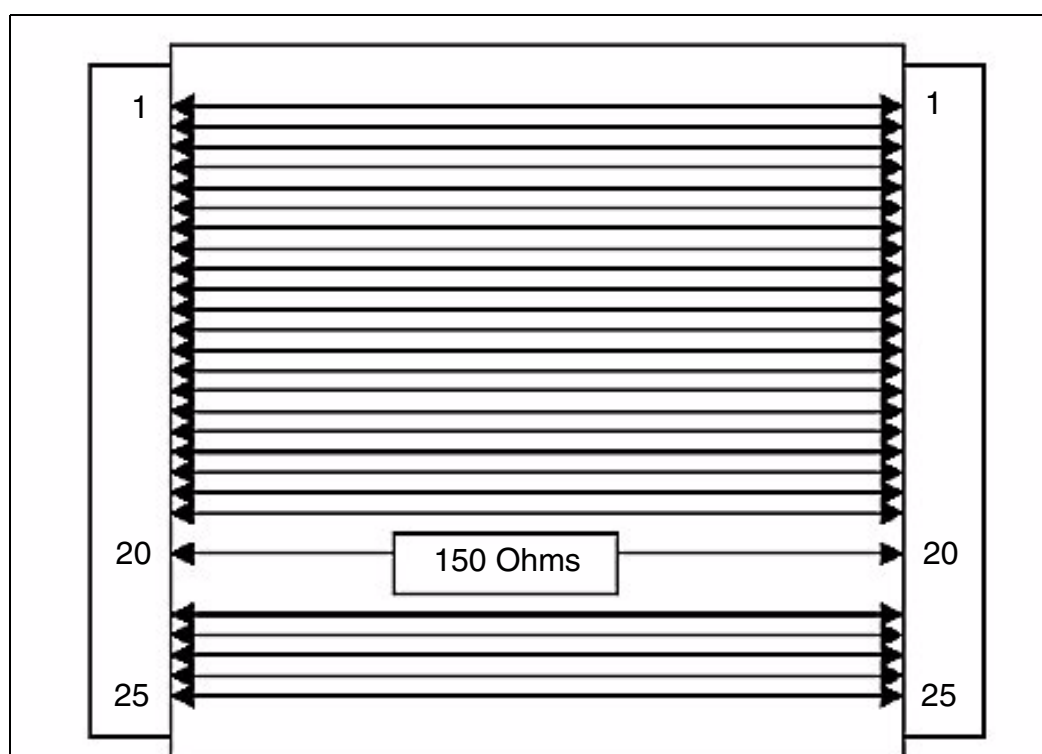
Fig. 3 Cable adapter 617-175 wiring schematic

The 25 way adapter cable has a 150 ohm resistor fitted inside , across the wire going between pins 20 ([Fig. 3](#)). The male and female plug and socket are wired pin for pin except on pin 20 which has the 150 ohm resistor in line.

This resistor will reduce the 80k shield temperature reading on the control crate by 12 - 15k.

The cable adapter 617-175 has been designed to reduce the voltage output from the 80k shield measurement in order to produce a lower input to the alarm trip on the control crate unit.
