Repair Instructions – Service No./Modi, Error list

1 Service and Access Codes/Release Option

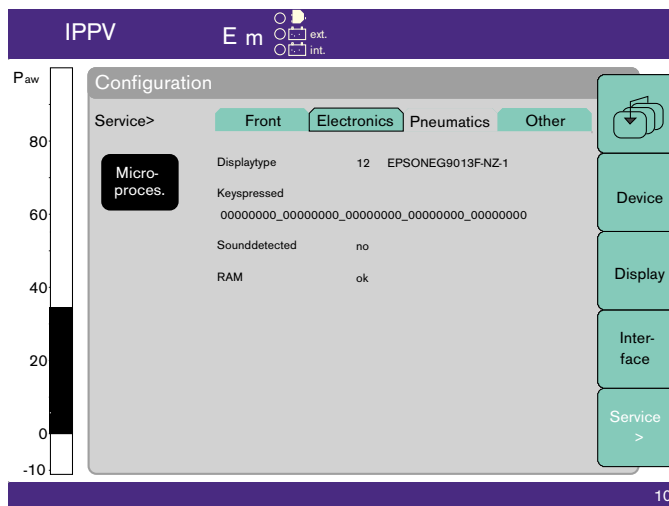
Evita 2 dura

3.2.1 Diagnosis page “Microprocessor” of “Front”

Display type

Readout of display in control panel. This information is of importance for renewal of background illumination, as this differs from display to display.
