# TOP-X

## HIGH FREQUENCY X-RAY GENERATORS

**MODEL: TOP-X 100NR**

# **SERVICE MANUAL**

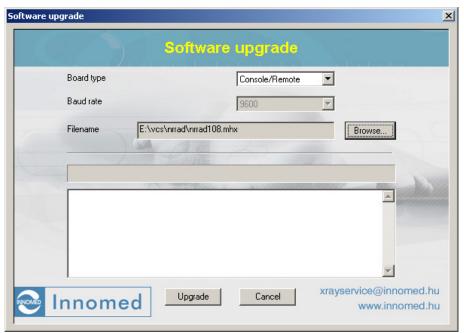
- 1. Start service program topxnr.exe.
- 2. Select menu **Data transfer / Software upgrade...**:

- 3. Select board type ('Console/Remote' or 'NRMCU' or 'NRCON')
- 4. In case of NRCON set baud rate to 9600 for NRCON105 (or below) or to 38400 for NRCON107 (or above).
- 5. Select program file to download with **Browse...** button.
- 6. Click **Upgrade** button. A message box appears:
