# MIDWEST IMAGING INC.

### iU22 Power Supply Test Points PN: 4535-6119-5282

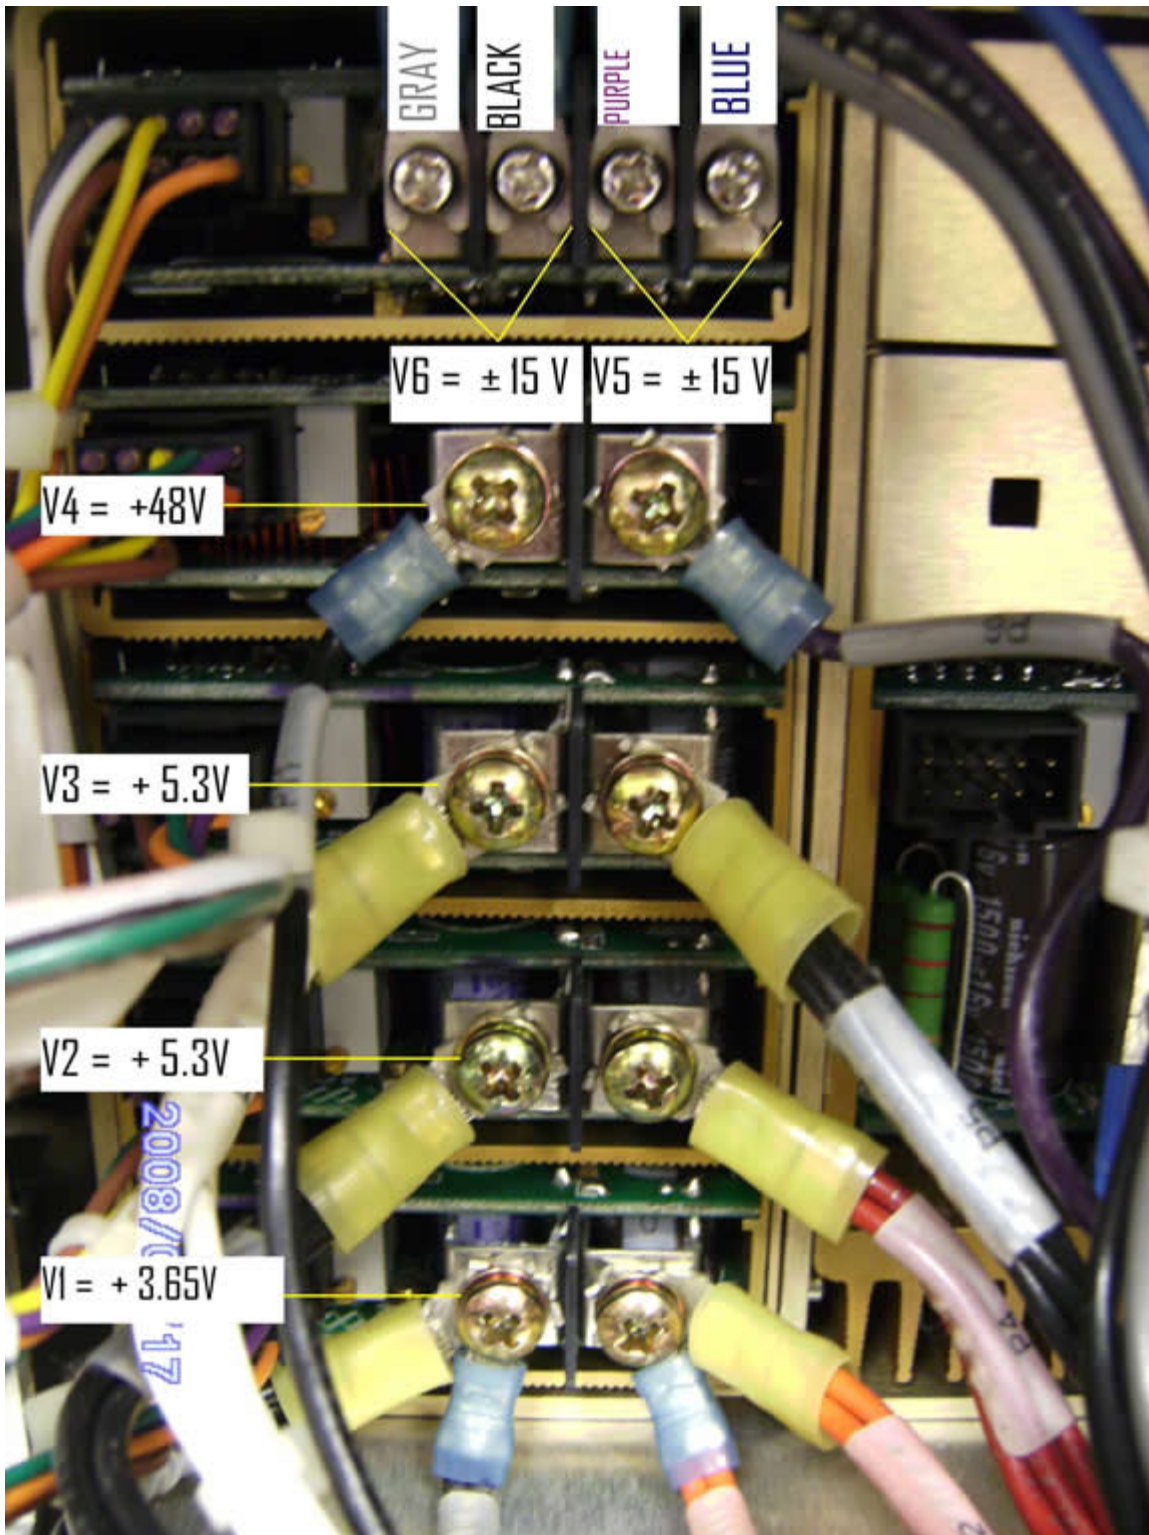
As a technician, you first need to verify that the symptoms reported are accurate. If they are, first instinct is to head straight to the power supply. Our technical support staff has provided system voltage test points (all voltages must be within 2% to 5% tolerance), each supply has a potentiometer to adjust voltage within its tolerance limit. If your power supply is not adjustable, please call our support staff for technical assistance and we'll help you be the hero of the day.
